RESEARCH MEMORANDUM

ALTITUDE-WIND-TUNNEL INVESTIGATION OF A 3000-POUND-THRUST

AXIAL-FLOW TURBOJET ENGINE

VII - PRESSURE AND TEMPERATURE DISTRIBUTIONS

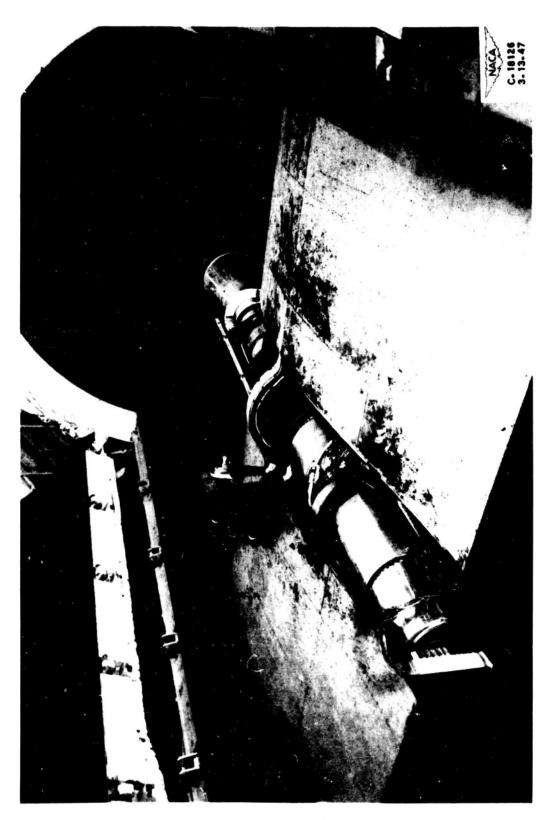
Figure 1. - Installation of turbojet engine in altitude wind tunnel.

The engine was installed in a wing nacelle in the test section of the altitude wind tunnel (fig. 1). Compressor-inlet pressures corresponding to high flight Mach numbers were simulated by introducing dry refrigerated air from the tunnel make-up air system through a duct to the engine inlet. This air was throttled from approximately sea-level pressure to the desired pressure at the compressor inlet while the static pressure in the tunnel was maintained to correspond to the desired altitude. The duct was connected to the engine inlet by means of a slip joint with a labyrinth seal, which permitted engine-thrust and installation-drag measurements to be made with the tunnel balance scales.

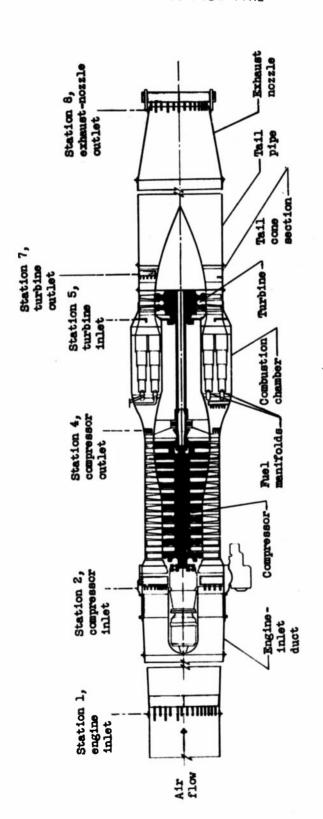
Figure 2. - Location of instrumentation in falled in turbojet engine.

Temperature and pressure measurements were obtained at several stations through the engine (fig. 2). Drawings of the instrumentation at the compressor inlet, the compressor outlet, the turbine inlet, the turbine stator stages, the turbine outlet, and the exhaust-nozzle outlet are presented in figures 3 to 8, respectively.

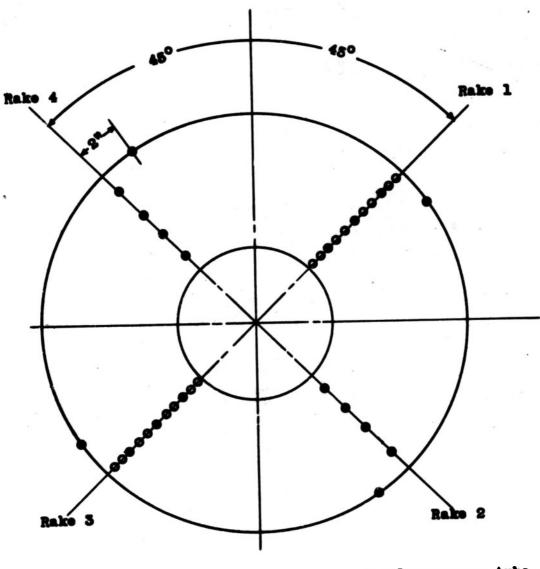
- Total-pressure tube Static-pressure tube
- Thermocouple

Figure 3. - Location of instrumentation at compressor inlet, station 2, $\frac{5}{4}$ inch behind rear flange of oil cooler.

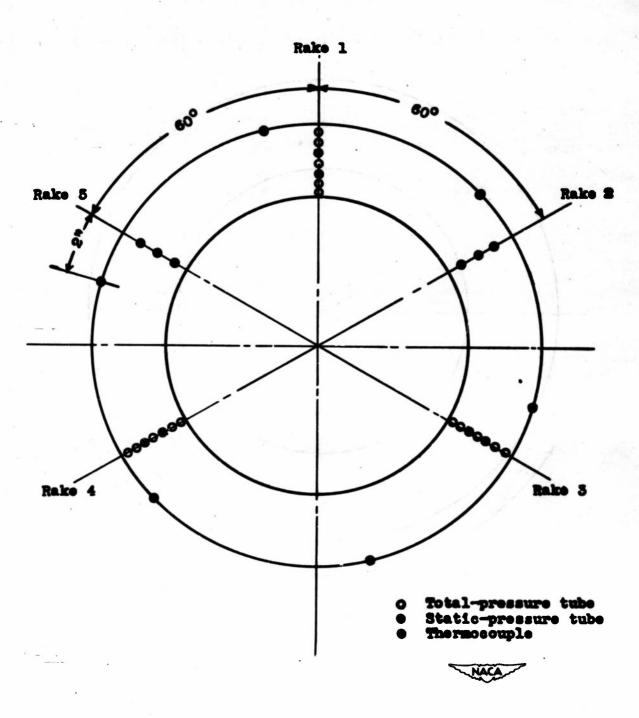
Figure 4. - Location of instrumentation at compressor outlet, station 4, $1\frac{1}{2}$ inches behind trailing edge of compressor—outlet straightening vanes.

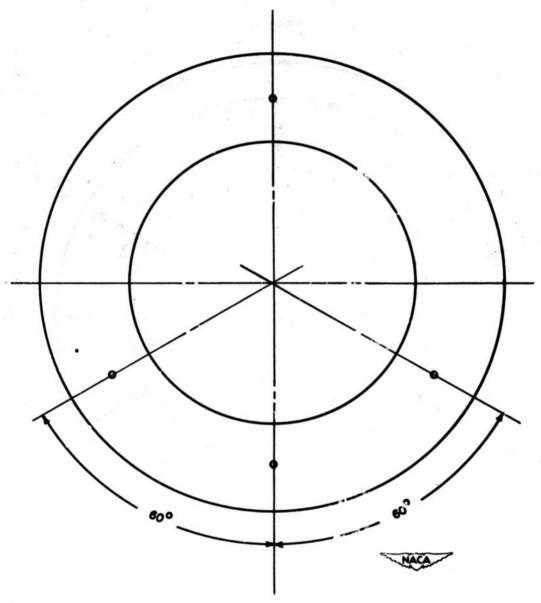
o Total-pressure tube

Figure 5. - Location of instrumentation at turbine inlet, station 5, 25 inches in front of center line of fix the turbine stator blade.

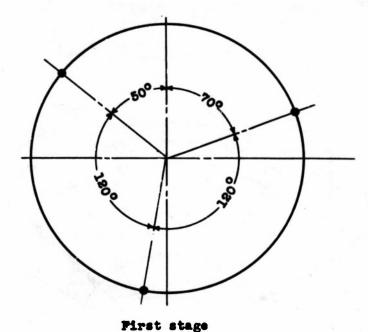
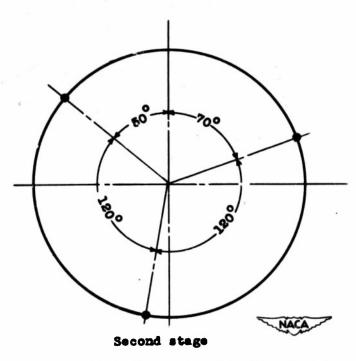
Figure 6. - Location of static-pressure tubes at turbine stator stages, station 6, center line of each stator blade.

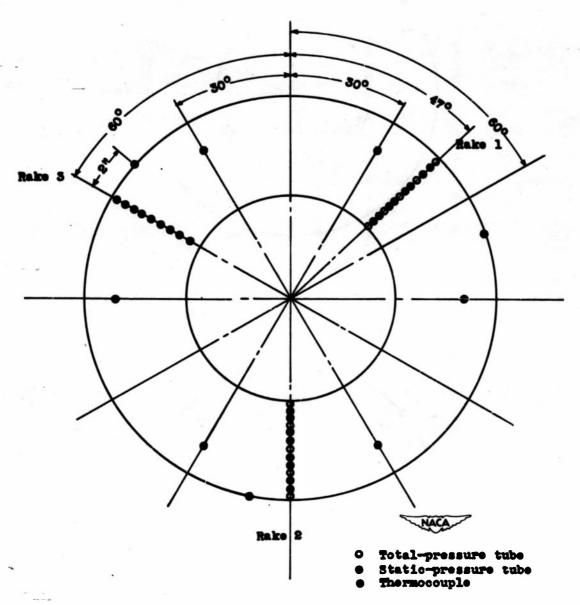
Figure 7. - Location of instrumentation at turbine outlet, station 7, $3\frac{5}{4}$ inches behind rear flange of turbine casing.

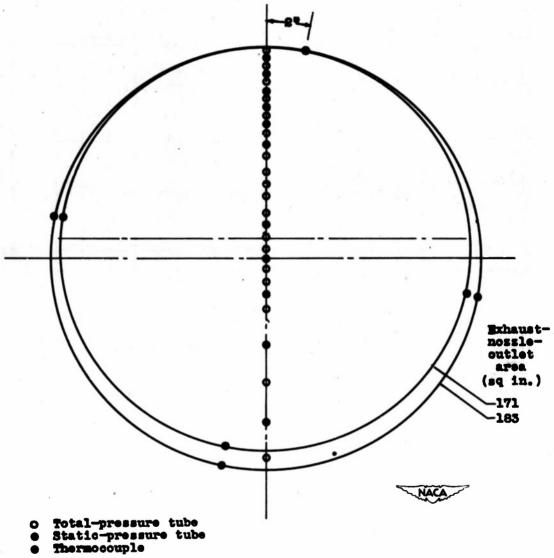
Figure 8. - Location of instrumentation in exhaust-nozzle outlet, station 8, 1 inch in front of rear edge of exhaust-nozzle outlet.

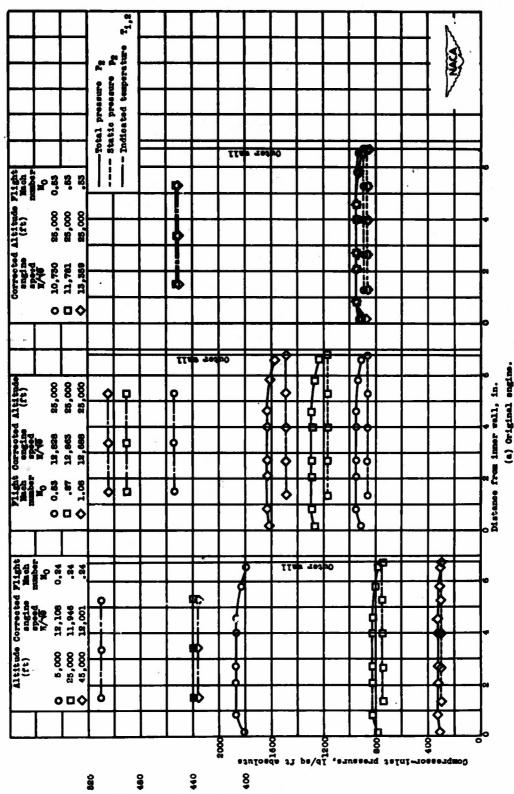
and sagine speed on radial distribution of total pressure, statio pressure, and indicated temperal at compressor inlat, station 2. Pigure 9. - Effect of altitude, flight Bach number,

The radial distribution of total pressure, static pressure, and indicated temperature at the compressor inlet is shown in figure 9 for the original and modified engines. Total- and static-pressure levels for both engines were nearly the same at each operating condition. The maximum variation of temperature levels between the two engines at any operating conditions was about 15° F.

Total-pressure, static-pressure, and indicated-temperature distributions were uniform across the passage for both engines at all operating conditions investigated, with the exception of slightly lower total pressures near the walls due to the boundary layer.

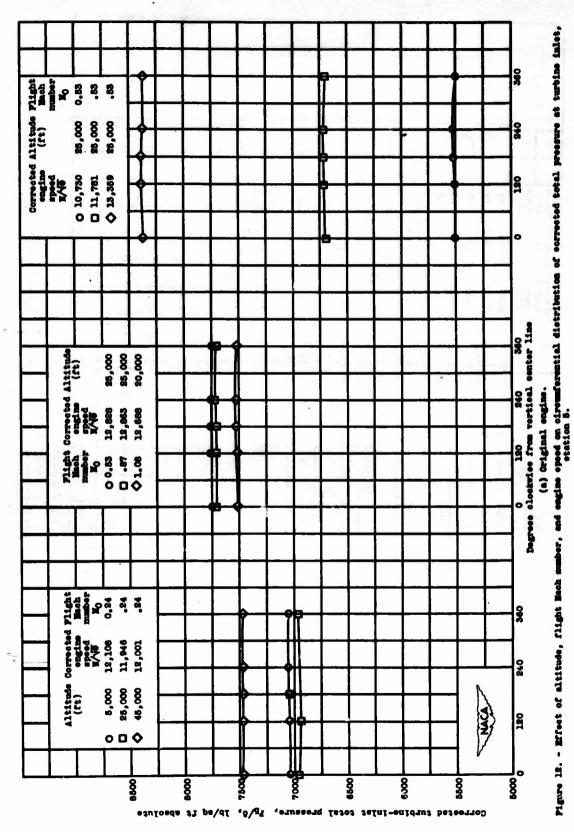
Figure 12. - Concluded. Effect of altitude, flight Mach number, and engine speed on circumferential distribution of corrected total pressure at turbine inlet, station 5.

Circumferential distribution of corrected total pressure P_5/δ at the turbine inlet is shown in figure 12 for the original and modified engines. The total-pressure distribution was uniform for both engines at all operating conditions. Changes in altitude, flight Mach number, or engine speed affected only the pressure level.

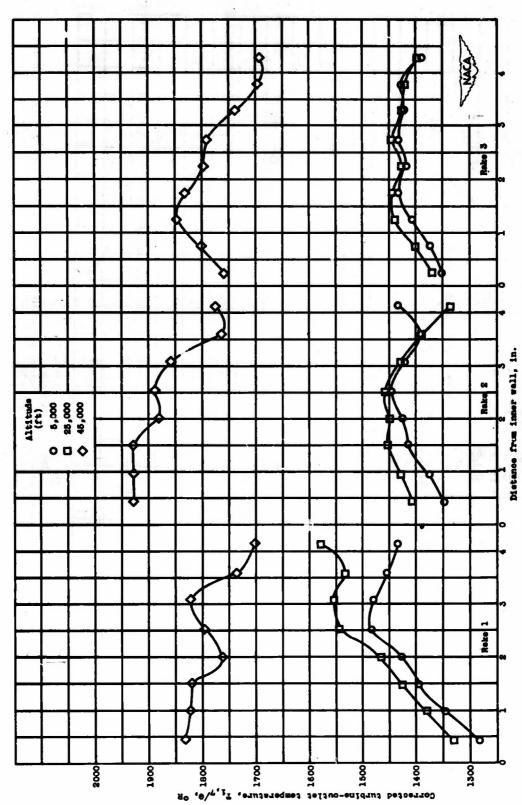
Figure 14. - Effect of altitude on redial distribution of corrected indicated temperature at turbine cutlet, station 7. Flight Mech number, 0.26; corrected angine speed, approximately 12,000 rpm.

Figure 14. - Concluded. Effect of altitude on radial distribution of corrected indicated temporature at turbine outlet, station 7. Flight Mech musher, 0.24; corrected engine speed, approximately 12,000 rpm.

from 5000 to 45,000 feet is presented in figure 14 for the original and modified engines at a flight Mach number of 0.24 and a corrected engine speed of about 12,000 rpm. The turbine-outlet temperature distribution for the original engine (fig. 14(a)) was not affected, except near the outer wall, when the altitude was increased from 5000 to 25,000 feet. At an altitude of 45,000 feet, the temperature at the inner wall increased with respect to the temperature at the outer wall to such an extent that the highest temperatures occurred in the vicinity of the turbine-blade roots. For the modified engine (fig. 14(b)), the temperature distributions measured by each rake were similar for the range of altitudes investigated. For both engines, an ircrease in altitude from 5000 to 25,000 feet generally resulted in a small increase in the corrected temperature level. Increasing the altitude beyond 25,000 feet, however, considerably increased the temperature level.

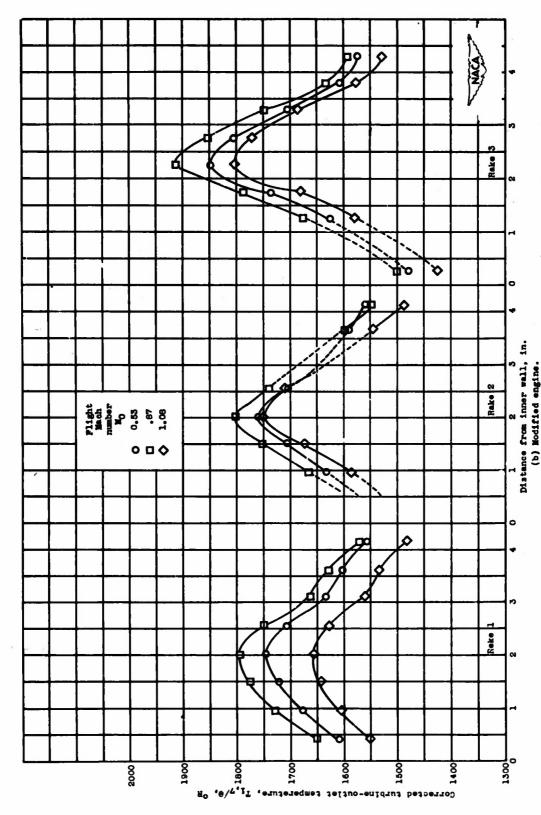
Figure 15. - Concluded. Effect of flight Mech rumber on rediel distribution of corrected indicated temperature at turbine outlet, station 7. Altitude, 25,000 feet; corrected engine epecd, approximately 12,700 rpm.

The radial distribution of corrected temperature at the turbine outlet for flight Mach numbers from 0.53 to 1.08 is presented in figure 15 for both engines at an altitude of 25,000 feet and a corrected engine speed of about 12,700 rpm. For both engines, changes in flight Mach number did not affect the temperature distribution. An increase in flight Mach number decreased the corrected temperature level except at a flight Mach number of 0.87 for the modified engine. The corrected engine speeds at flight Mach numbers of 0.53 and 1.08 for the modified engine were somewhat lower than at the comparable conditions for the original engine and, consequently, the temperature levels are not in the same sequence with increasing flight Mach number as shown for the original engine.

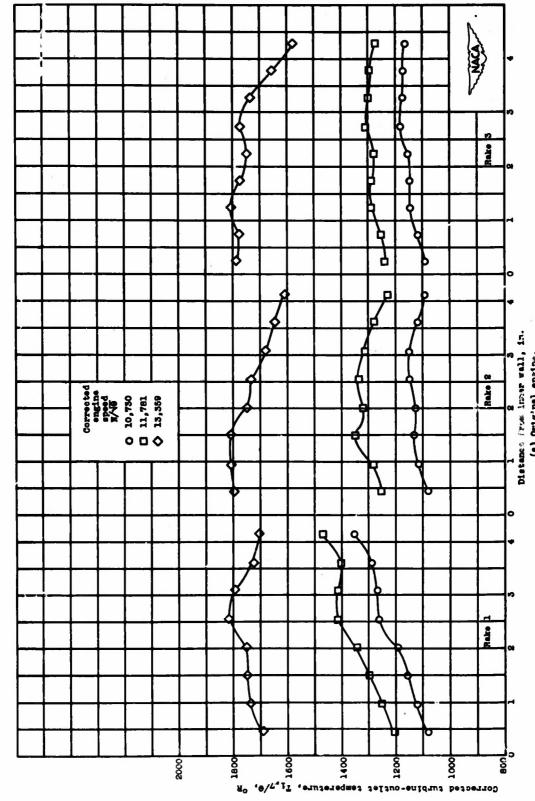
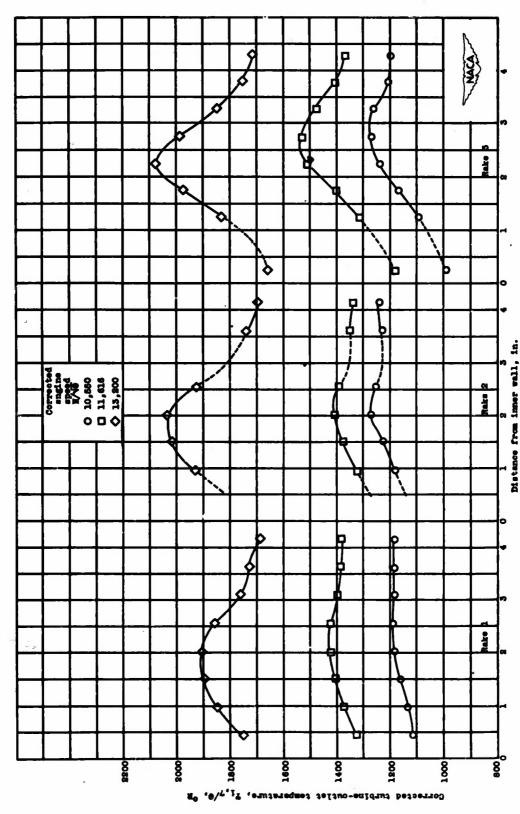
Figure 16. - Effect of engine speed on radial distribution of corrected indicated temperature at turtine outlac, station 7. Altitude, 25,000 feet; fight Mach number, 0.53.

Figure 16. - Concluded. Effect of engine apead on radial distribution of corrected indicated temperature at turbine outlet, atation 7. Altitude, (b) Modified engine.

The effect of corrected engine speed on the radial distribution of corrected indicated temperature at the turbine outlet is shown in figure 16 for both engines at an altitude of 25,000 feet and a flight Mach number of 0.53. Increasing the corrected engine speed moved the temperature peak toward the root sections of the turbine blades. However, this effect was more pronounced for the original engine than for the modified engine. At the highest engine speed for the modified engine (fig. 16(b)), the maximum temperature at each rake position occurred in the central part of the passage.

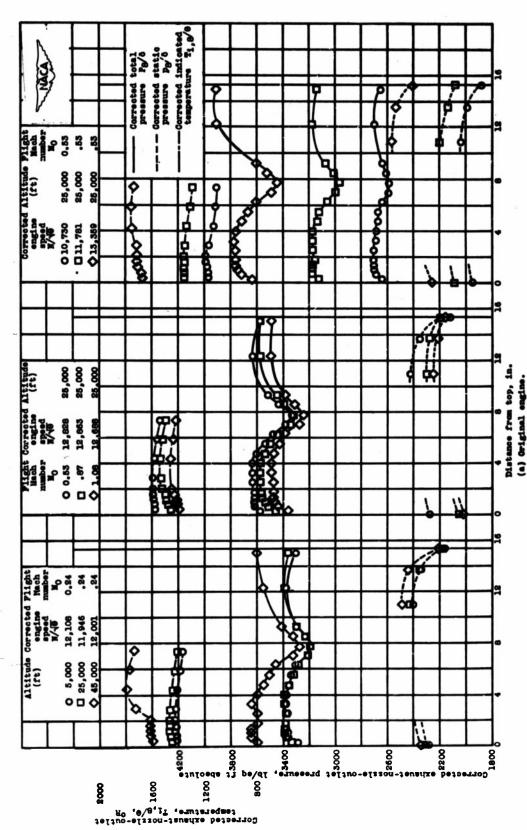
Pigure 19. - Effect of altitude, flight Mach number,

Pigure 19. - Concluded. Effect of altitude, flight Beah number, and engine speed on distribution of corrected total pressure, static pressure, and indicated

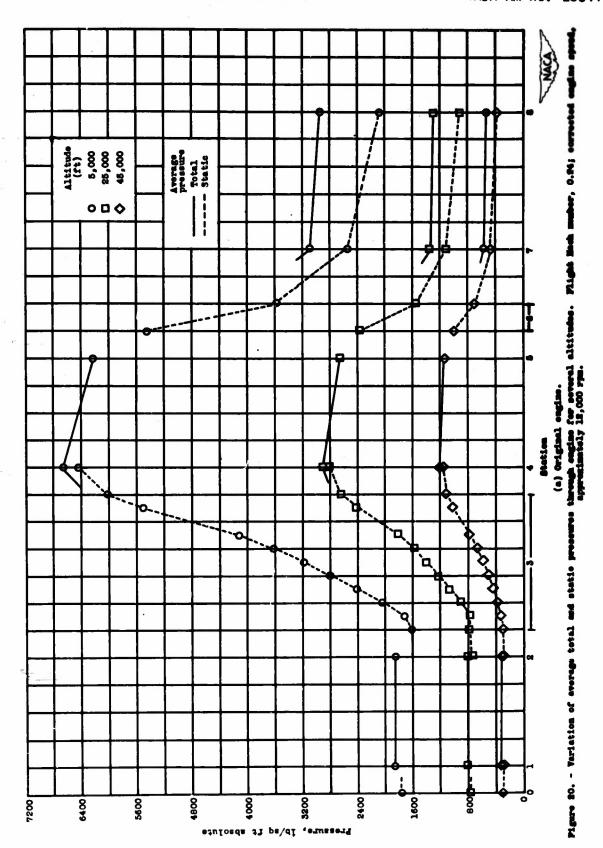
Pigure 20. - Concluded. Varietion of average total and etatic pressures through engine for several altitudes. Flight Mach number, 0.84; sorrected engine approximately 12,000 rpm.

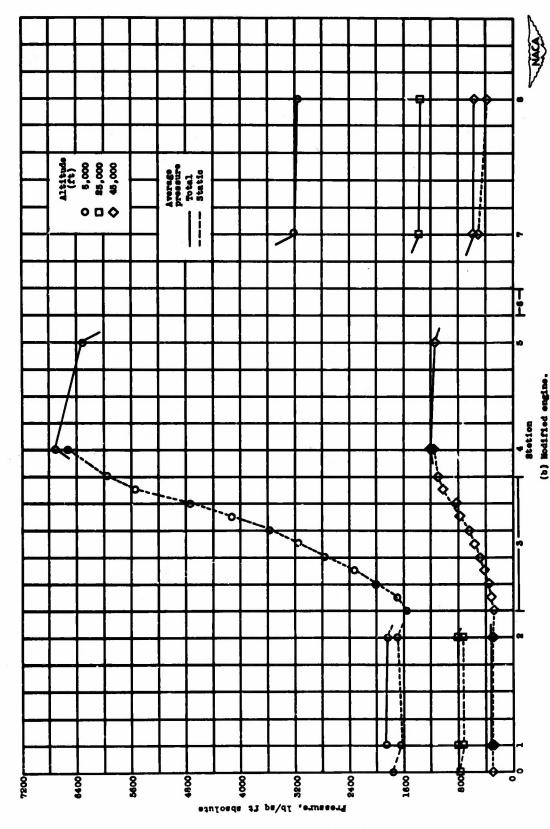
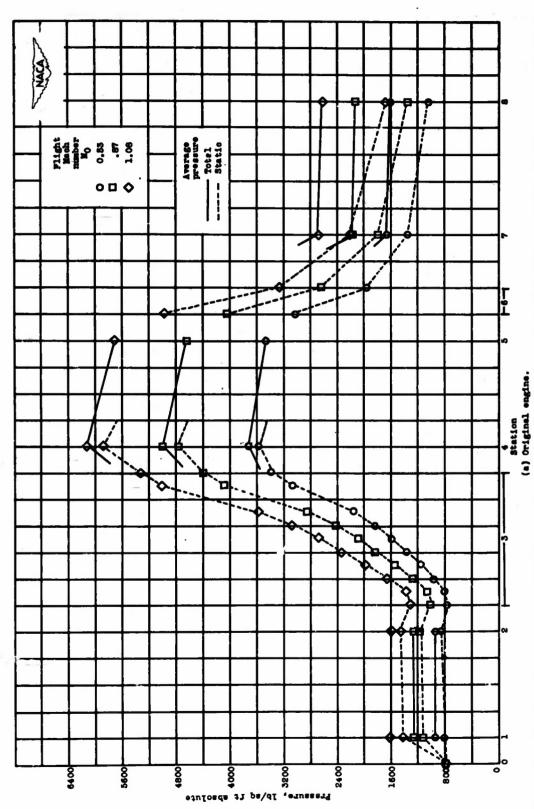
Figure 21. - Variation of everage total and static pressures through engine for several flight Mech numbers. Altitude, 25,000 feet; corrected engine speed, approximately 12,700 rpm.

Pigure 21. - Concluded. Varietion of everage total and static pressures through engine for several filght Mech numbers. Altitude, 25,000 feet; contracted engine epsec, approximately 12,700 rpm.
